Aviation Safety

Maintainer

Issue 2/2000

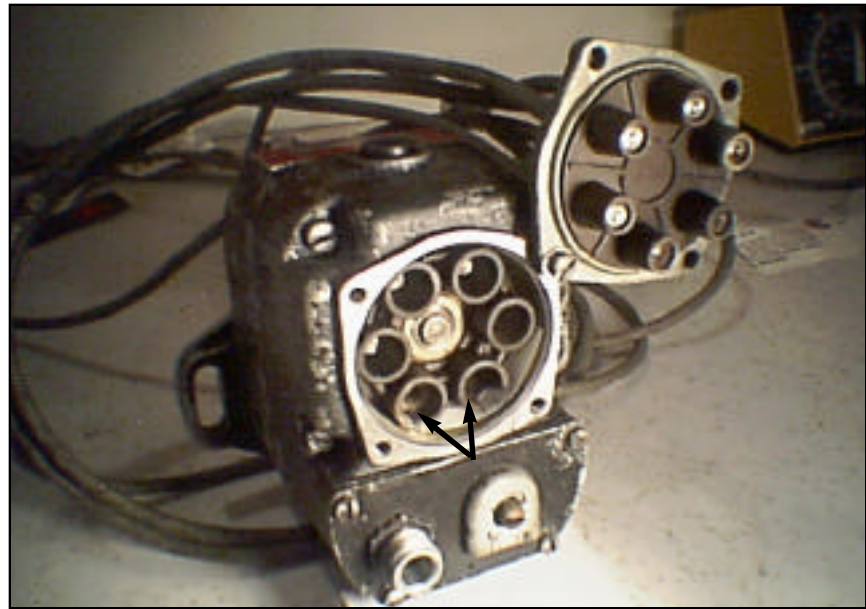
This is a magneto problem with a slightly different twist. The pilot noticed a magneto drop during run-up, and a maintenance check revealed that the magneto, a Bendix (model No. S6LN-21, serial No. 426019), had some burned lead attachment points on the bakelite collar of the distributor block (see arrows on photo). The magneto had been running only 255.5 hr. since major overhaul.

Consultation with a magneto overhaul expert revealed that the burnt collar area was likely caused by the breakdown in a spark plug or ignition lead, which tends to cause arcing, which, in turn, causes burning at some point in the system, in this case the bakelite terminal block lead collars. The leaking current follows the path of least resistance, in this case through the bakelite insulation. It is possible this block may also be brittle after 50 years of operation, during which it was subjected to a wide range of temperature variations. Therefore, it could have developed a small crack,

Note the damaged areas of the distributor block where the leads from the spark plugs attach.

allowing the leak to ground of the high-tension current and resulting in the corresponding damage to the block.

AMEs who work on these old aircraft equipped with 50-year-old magnetos, such as this Bendix S6LN-21 model, need to be on the alert for these

problems. Any cracks or burning of the distributor block may be the beginning of a more serious problem or loss of magneto in flight. This story was brought to my attention thanks to the diligence of Mr. Bill Pepler, owner of the Bonanza. 📧

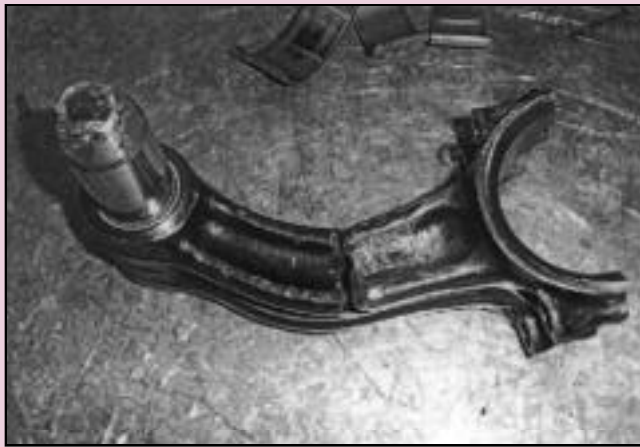
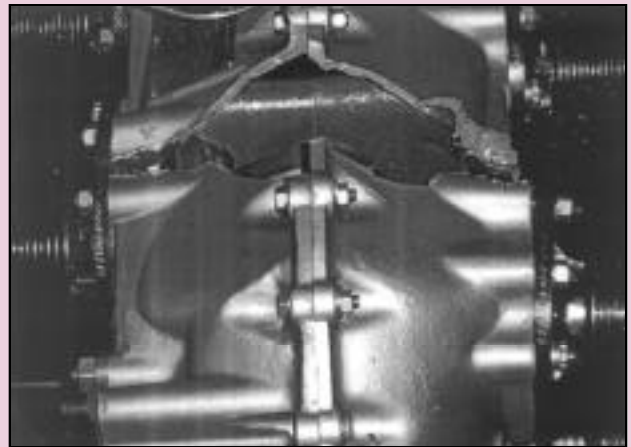
A recently overhauled IO 520M engine installed in a Cessna 310 failed in flight after 2.9 hr. of operational service. The damage was extensive, as illustrated in the accompanying photos of the broken connecting rod (left) and punctured crankcase. Preliminary information suggests that the failure may have been caused by a "hydraulic lock," the result of overpriming. Broken connecting rods are often caused by a hydraulic lock. 🛠️

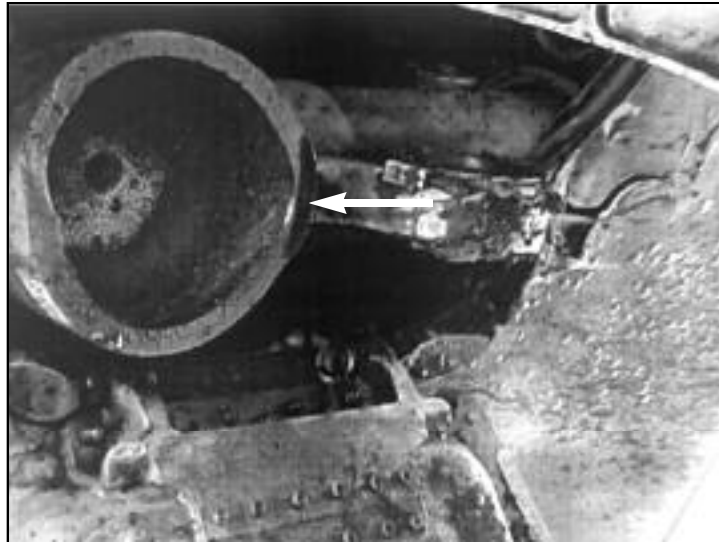
Sometimes things don't work out, as can be seen by the accompanying photos of a failed main landing gear oleo as removed from a regional jet that was in service with a foreign carrier.

The in-service failure of this "fatigue-lived" gear was due to a premature fatigue failure. This appears to be an isolated case; however, the start of the failure can be seen in the cross-section elliptical area (arrow) of the photo.

This is typical of fatigue failure and it shows how the failure progressed across the section by the beach marks, a term used to describe fatigue progression. The failure occurs when the fatigue damage reduces the cross-section strength below that which is required for its static and operational strength.

This is something that inspection will not usually find nor is it expected to find except by directed NDT (non-destructive testing). AMEs and inspectors should still keep a sharp eye out during routine inspections, focusing on high-wear and high-stress components, such as main and nose gear legs. A fatigue crack is usually very hard to spot with the naked eye, but if you locate something suspicious you always have the option of calling for NDTs to either substantiate your suspicion or rule out any concern. 🛠️
